STORMWATER ANALYSIS
INLAND AUTO GLASS

ANALYSIS PERFORMED BY:
HEDCO, INC
2014-06-25

**RE: Subsurface Exploration and Infiltration Testing Services
Proposed Inland Auto Glass Facility
7th Avenue North & 24th Street
Lewiston, Idaho 83501
ALLWEST Project No. 314-038G**

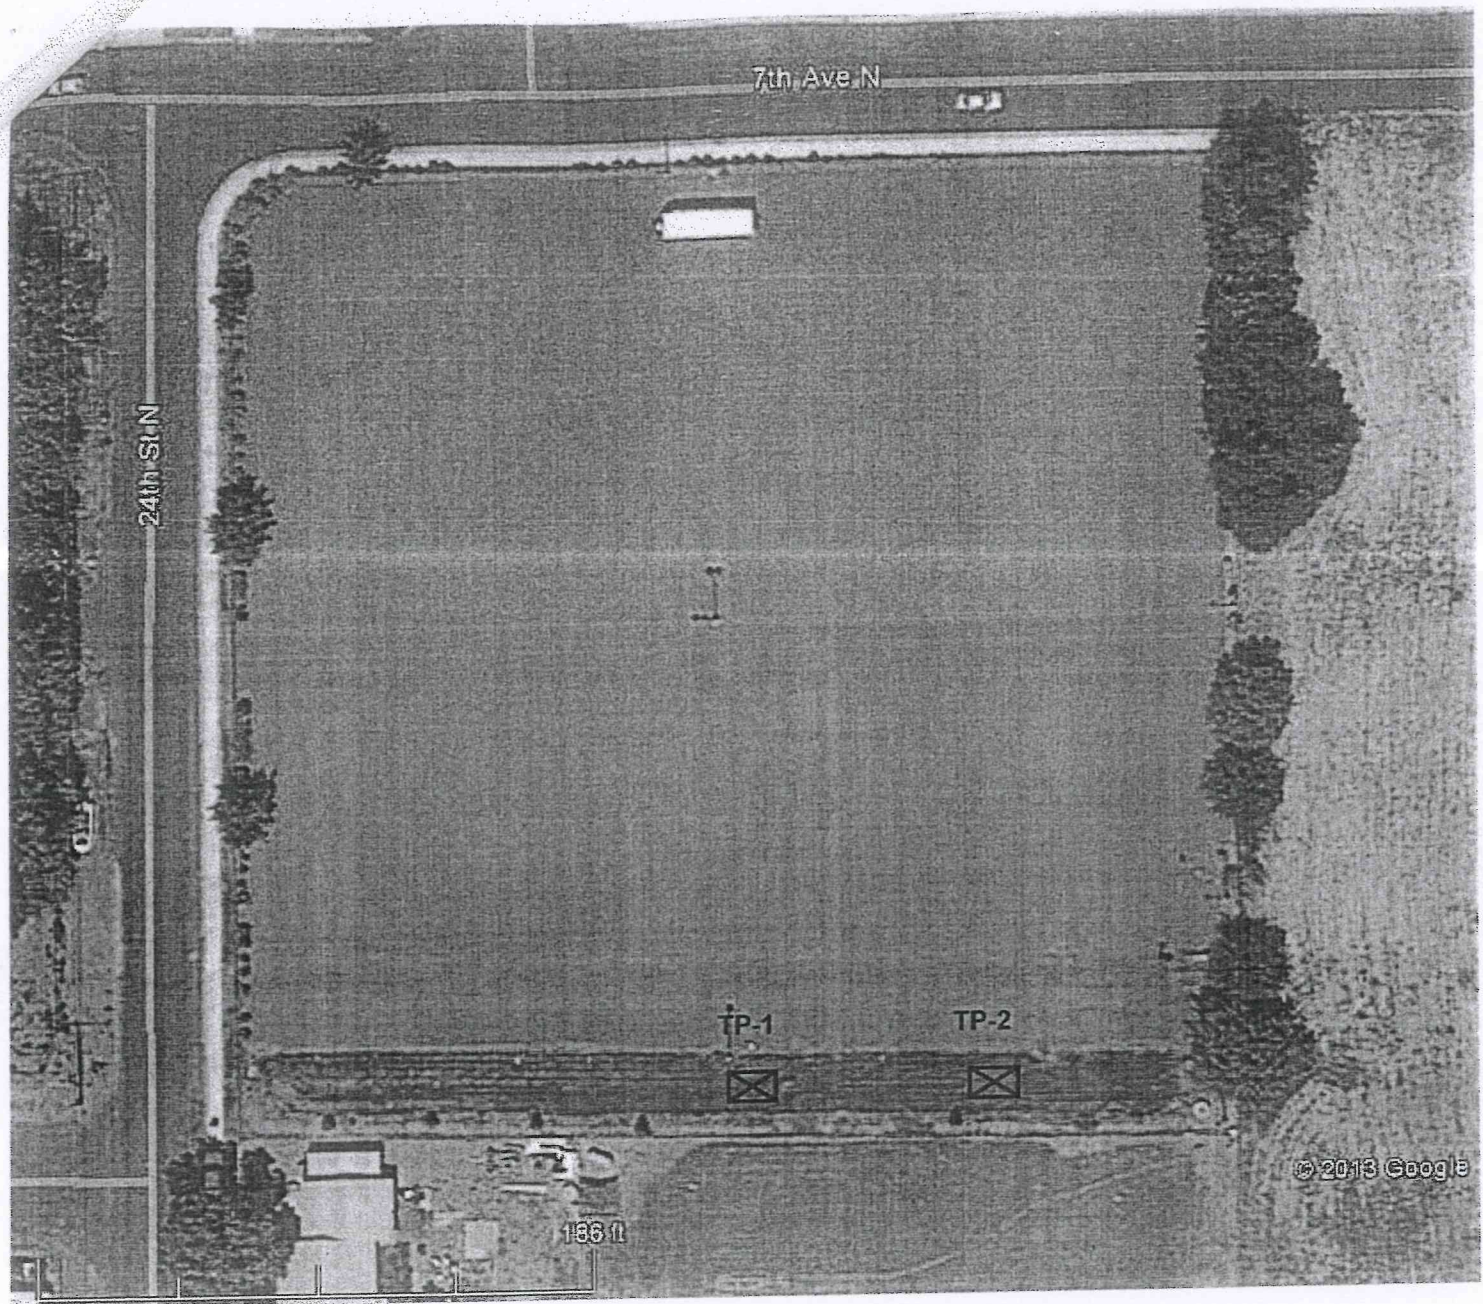
⊠ Approximate test pit location

PROJECT: 314-038G Inland Auto Glass Facility 7th Avenue N & 24th Street Lewiston, Idaho HEDCO			TEST PIT: TP-1	
			LOCATION: See Figure A-2	
			DATE: 3/3/2014	SCALE: 1" = 2'
Depth 0.0	ASTM D2487 Symbol	Description of Materials	WL	Tests or Notes
0	TS	SILT with sand; stiff, moist, roots, organics and dark brown to black.		
2	ML	SILT with sand; loose to medium dense, wet, slightly plastic and dark brown.		
4				
6	GP	Poorly graded GRAVEL with sand; cobbles, medium dense to dense, moist, fine to coarse-grained and light brown.		
8		End of test pit at an approximate depth of 7 1/2 feet.		
10				
12				
14

PROJECT: 314-038G Inland Auto Glass Facility 7th Avenue N & 24th Street Lewiston, Idaho HEDCO			TEST PIT: TP-2 LOCATION: See Figure A-2	
			DATE: 3/3/2014	SCALE: 1" = 2'
Depth 0.0	ASTM D2487 Symbol	Description of Materials	WL	Tests or Notes
0	TS	SILT with sand; stiff, moist, roots, organics and dark brown to black.		
2	ML	SILT with sand; medium dense, moist to wet, non-plastic and brown.		
4				
6	SM	Silty SAND; medium dense, moist to wet, fine to medium-grained, non-plastic and light brown.		
8	GP	Poorly graded GRAVEL with sand; cobbles, medium dense to dense, moist, fine to coarse-grained and light brown.		
10		End of test pit at an approximate depth of 9 1/2 feet.		
12				
14
